# Manhole Inspection Summary

Manhole # S29E\_\_031MH

Insp Date: **9/23/08 11:10 AM**

**Location** Address: **116 Vine St**

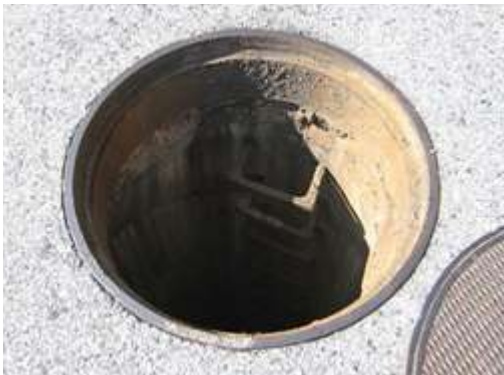
Frame View

Condition: ☐ Sound ☐ Cracked ☒ **Leaks**

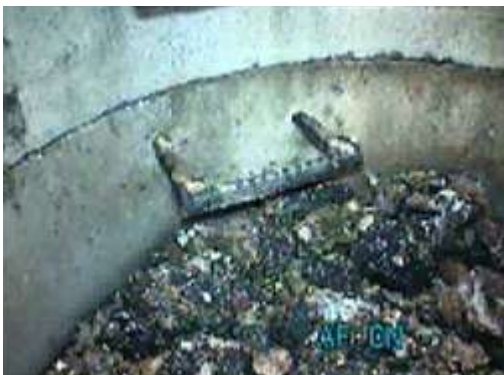
Defect 3

Condition: ☐ Sound ☐ Cracked ☐ Root Intrusion ☐ Deteriorated ☐ Leaks ☒ **Debris**

debris on bench

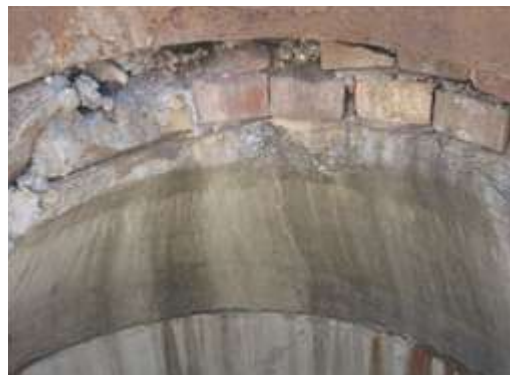
Defect 2

Condition: ☐ Sound ☒ **Cracked** ☐ Root Intrusion ☐ Loose Brick ☒ **Deteriorated**

Deterioration of mortar under frame

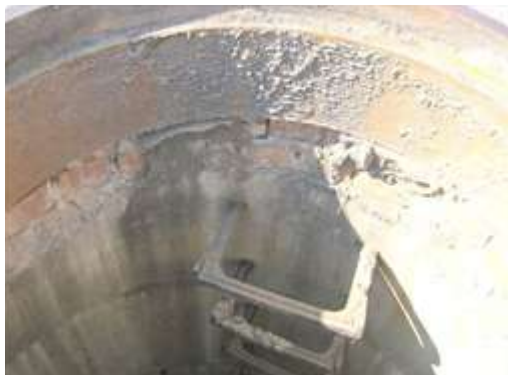
Defect 4

evidence of infiltration from frame

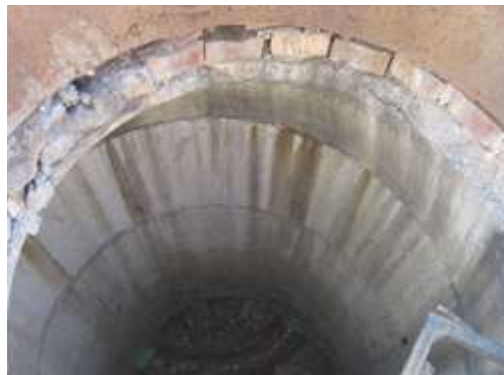
Defect 1

Infiltration: ☐ None ☐ Joint ☐ Cracks ☐ Mortar ☐ Roots ☒ **Wall**

Infiltration along chimney wall

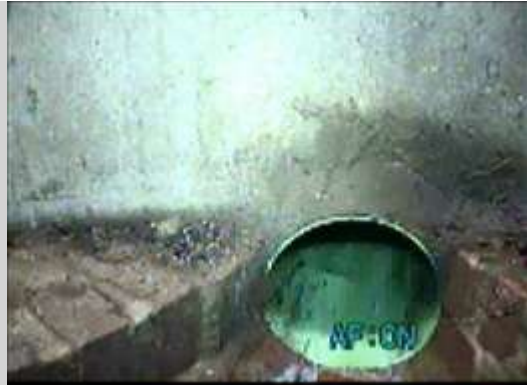
12 O'Clock Outflow

Pipe Height: **8.4** (in.) Rod and Bar (Angled)  
Pipe Material: **PVC** ☐ Pipe Lined  
Invert Depth: **10.47** (ft.) Flow Characteristics: **Slow**  
Deposits: ☒ None ☐ Mud ☐ Sludge ☐ Debris ☐ Grease  
Silt Depth: **0** (in.) Deposits Extent:  
Infiltration: **None** Pipe Seal Cond: **Sound**

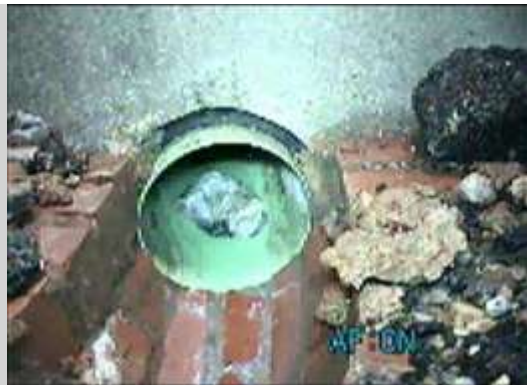
3 O'Clock Inflow

Pipe Height: **8.4** (in.) Rod and Bar (Angled)  
Pipe Material: **PVC** ☐ Pipe Lined  
Invert Depth: **10.21** (ft.) Flow Characteristics: **Slow**  
Deposits: ☒ None ☐ Mud ☐ Sludge ☐ Debris ☐ Grease  
Silt Depth: **0** (in.) Deposits Extent:  
Infiltration: **None** Pipe Seal Cond: **Sound**

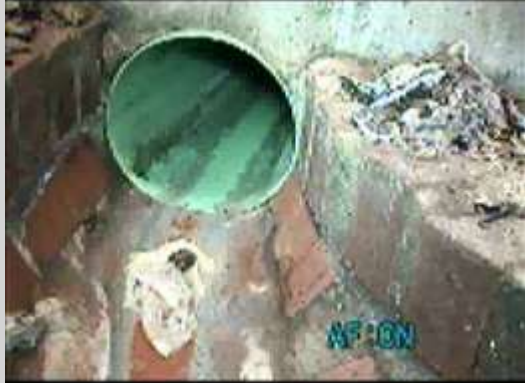
9 O'Clock Inflow

Infiltration: **None** Pipe Seal Cond: **Sound**
